GROUP 21

DESCRIPTION

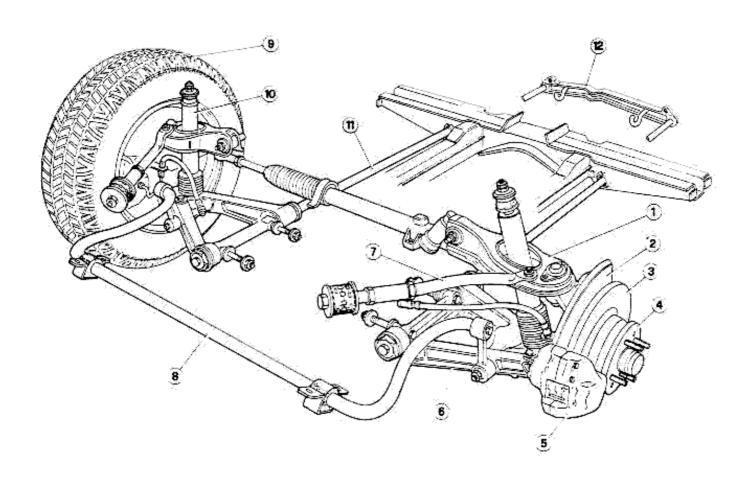
- Upper link
- 2 Splash guard 3 Brake disc
- 4 Wheel hub
- 5 Brake caliper
- 6 Lower lin≱
- 7 The roat
- 8 Anti-roll bar
- 9 Front wheel
- 10 Shock absorber
- 11 Torsion bar
- 12 Rear cross member

Front suspension is independent, connected to body by transverse links. Two longitudinal torsion bars are connected at the front to the links and at the rear to the chassi

Front suspension also includes by draulic double-acting shock absorbers connecting body and lower links

and an anti-roll bar improving stability on cornering. Link upward and downward movement is restricted by bump blocks secured to cross member.

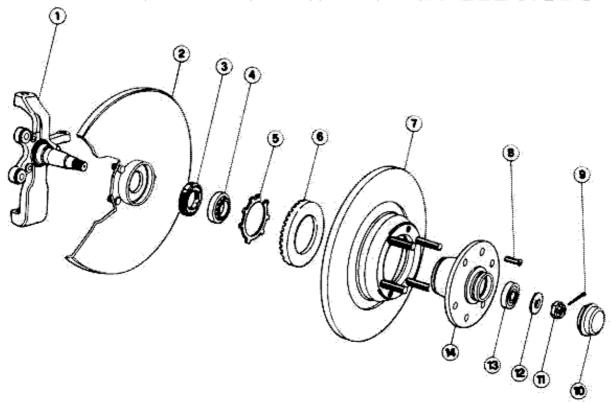
- 1 Steering knuckle
- 2 Splash guard
- 3 Seal
- 4. Inner bearing
- 5 Retaining ring (*/

- 6 impulse emitting wheel (*)
- 7 Brake disc
- 8 Capscrew
- 9 Cotter pin
- 10 Hub cover

- 1 Not
- 12 Washer
- 13 Outer bearing
- 14 Wheel hub

(*) For vehicles equipped with (ABS) MARK II wheel antilock braking system only

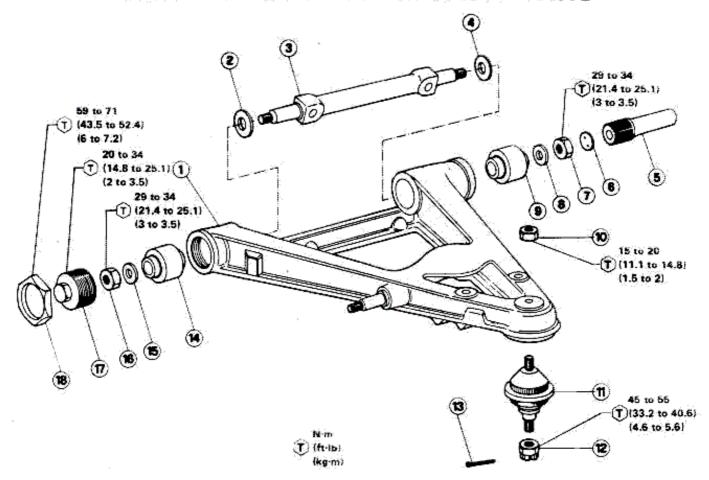
- Lower Sink
- Washer
- Link support
- Washer
- Torsion bar
- Plastic cover
- REMOVAL
- 1. Proceed as specified in Steering
- Knuckles and Wheel Hubs Removal" up to para. 8 (excluding step 5). 2 Remove cover 1 from torsion bar seat (2).

- Nus
- Washer
- Rear bust
- Ball joint nut
- Ball joint
- Steering knuckle nut
- Mark torsion bar at front and rear, install tool A.3.0374 and nut along with forcing screw A.3.0374/0001 and remove torsion bar from seat.
- Coner pin
- Front bush
- 15 Washer
- 16 Nut
- Lockring
- Retaining nut
- Back off boits (1) and remove lower link (2) retrieving spacers.

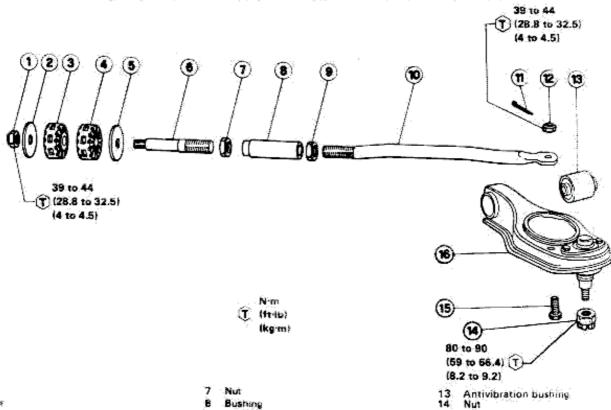
- None
- Washer 2
- Bump block
- Bump block
- Washer
- Outer pin
- UPPER LINKS

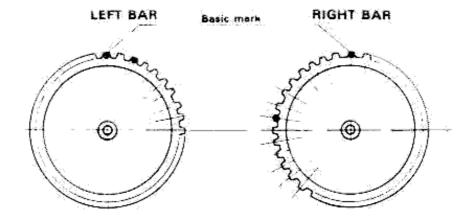
Rear view (cross member side)

f) It is emphasized that for a lower trim, by rotating the left bar CCW and the right bar CW, the trim value increases. For greater trim: by rotating the left bar CW and the right bar CCW, the trim value decreases.

Front trim adjustment is accomplished by rotating the torsion bars with respect to reference notes on the front links and rear cross member.

The different number of serrations (35 at the front, 34 at the rear) allows small trim corrections, about 2.5 mm(0.1 in) to be made by repositioning by one tooth at both ends.
